COAL MINE SAFETY AND HEALTH  
AMENDED REPORT OF INVESTIGATION

Fatal Fall of Roof Accident (Amended)  
March 29, 2006  
(Victim Died April 10, 2006)

No. 4 Mine  
Jim Walter Resources, Inc.  
Tuscaloosa County, Alabama  
I.D. No. 01-01247

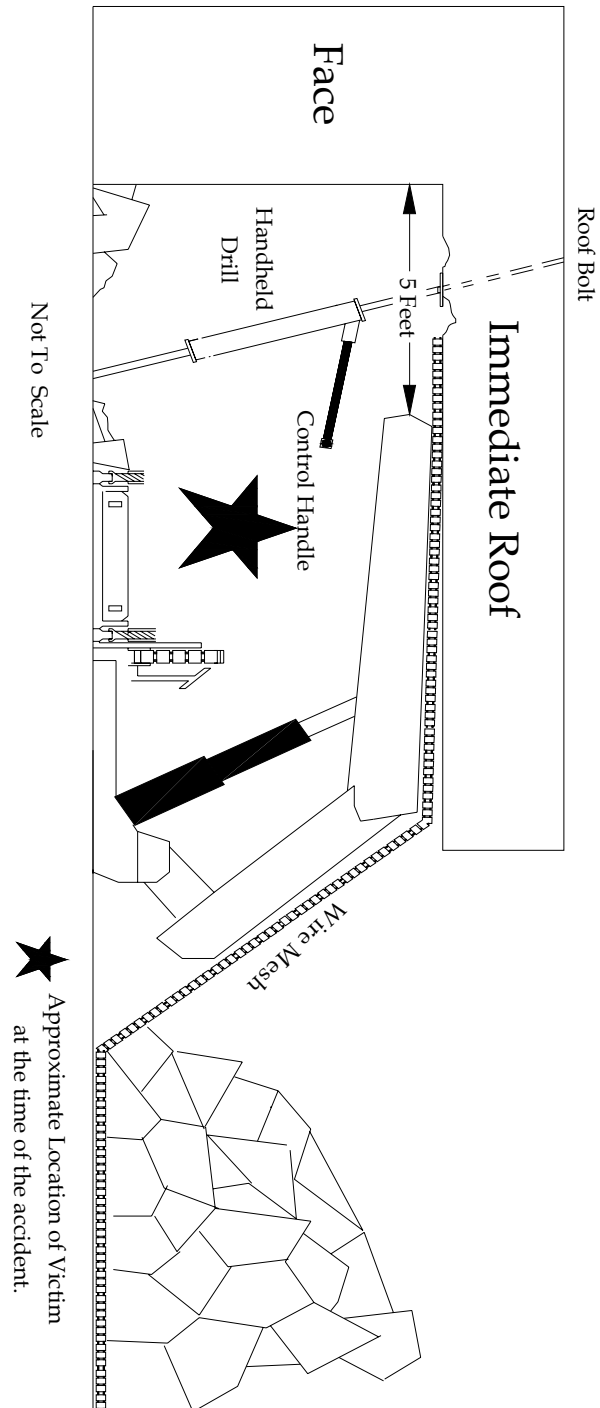
### Longwall Work Area

The rock that separated from the roof and struck the victim was approximately 4-inches x 12-inches x 24-inches.

The accident occurred when a longwall roof drill operator was struck by rock that fell from between the longwall face and the shield tips, causing the miner to fall and strike his head against the pan-line. The victim was working at this location because the mine operator's procedures for installing roof bolts along the face during longwall shield removal did not include provisions for safe positioning of the drill operator as roof bolts were installed.

- "The pin men will position their drill perpendicular to the faceline while standing under a shield canopy to install their first pins in all areas where pinning will be started in the mesh cycle."
- "The pin men will position themselves adjacent to previously installed bolts as they progressively pin the faceline in all areas of pinning."
